CASE REPORT

Role of physical properties of dental restorative biomaterials in criminalistics

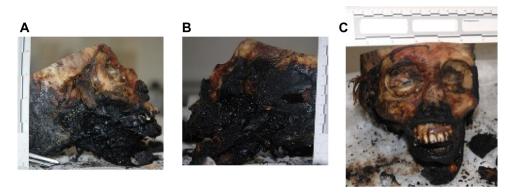
Figure 2 The (A and B) lateral and (C) frontal views of the skull.

After removing the soft tissues from the skull, the hard tissues showed several degrees of burn damage. The skull had more extensive burn destruction in the lower third than in the upper third (Figure 2). The right side of the skull showed more burn damage than the left side, with more bone fragmentations, mainly in the lower jaw.

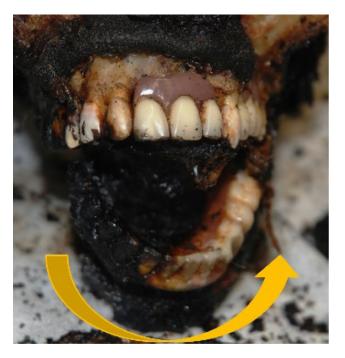
Figure 3 Frontal view of the oral cavity.

Analysis of the intraoral cavity showed two acrylic resin removable prosthodontic rehabilitations: both upper and lower. In the lower one, we can observe that the fire direction was from right to left and the fire intensity was higher on the right side than on the left side. The lower prosthodontic rehabilitation was carbonized on the right side but not on the left side. The morphology of the acrylic teeth was conserved on the left side of the lower jaw. When we compared the upper and the lower rehabilitations, we observed that the fire intensity was higher in the lower one (Figure 3).

Notes: The direction of the fire was from the right to the left side of the skull (arrow). The intensity of the fire was higher on the right side.

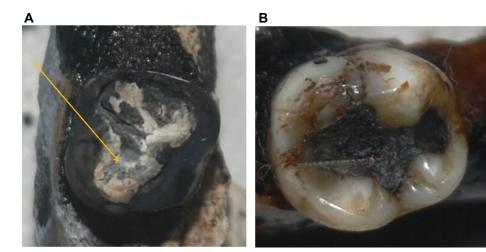
Figure 9 The teeth (A) 47 and (B) 37.

Notes: (A) Tooth 47 without the alloy filling, which was molten. As indicated by the arrow; the alloy was molten and there were traces of residual alloy on the floor of the cavity. (B) Tooth 37 with the dark metal alloy filling.

molar from the left side on the oclusal surface had a restoration of amalgam (Figure 9). The filling was present but was dark. The second molar of the right side had a cavity compatible with an amalgam filling (Figure 9). The alloy was molten and there were traces of residual alloy on the floor of the cavity.

The amalgam filling consisted of a eutectic alloy. The advantage of these alloys is that the low melting point allows work in the mouth. Conventional amalgam restorations darkened and pulverized at 300°C and roasting began at 800°C.8 At 1,000°C in situ in the filling, we only saw the shine of the silver in the second molar from the right side. 12 From the color of the filling from the second molar of the left side, we estimate that the fire temperature was near 300°C.

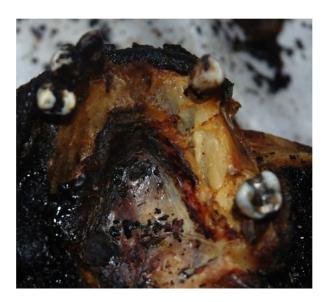
Figure 11 The burn damage on the upper jaw bone.

The visual appearance of the upper jaw was also compatible with a fire direction from the right to the left (Figure 10). The temperature intensity was higher on the right side than on the left. After removing the soft tissues and cleaning, the pattern injuries were the same in the lower

jaw (Figures 10 and 11). The acrylic resin from the upper denture was carbonized on the distal end of the right side (Figure 12), and this pattern was the same on the inner surface (Figure 12).
